Small Site Architecture of
Chaco Canyon
New Mexico

Peter J. McKenna
Marcia L. Truell

Publications in Archeology 18D
Chaco Canyon Studies

National Park Service
U.S. Department of the Interior

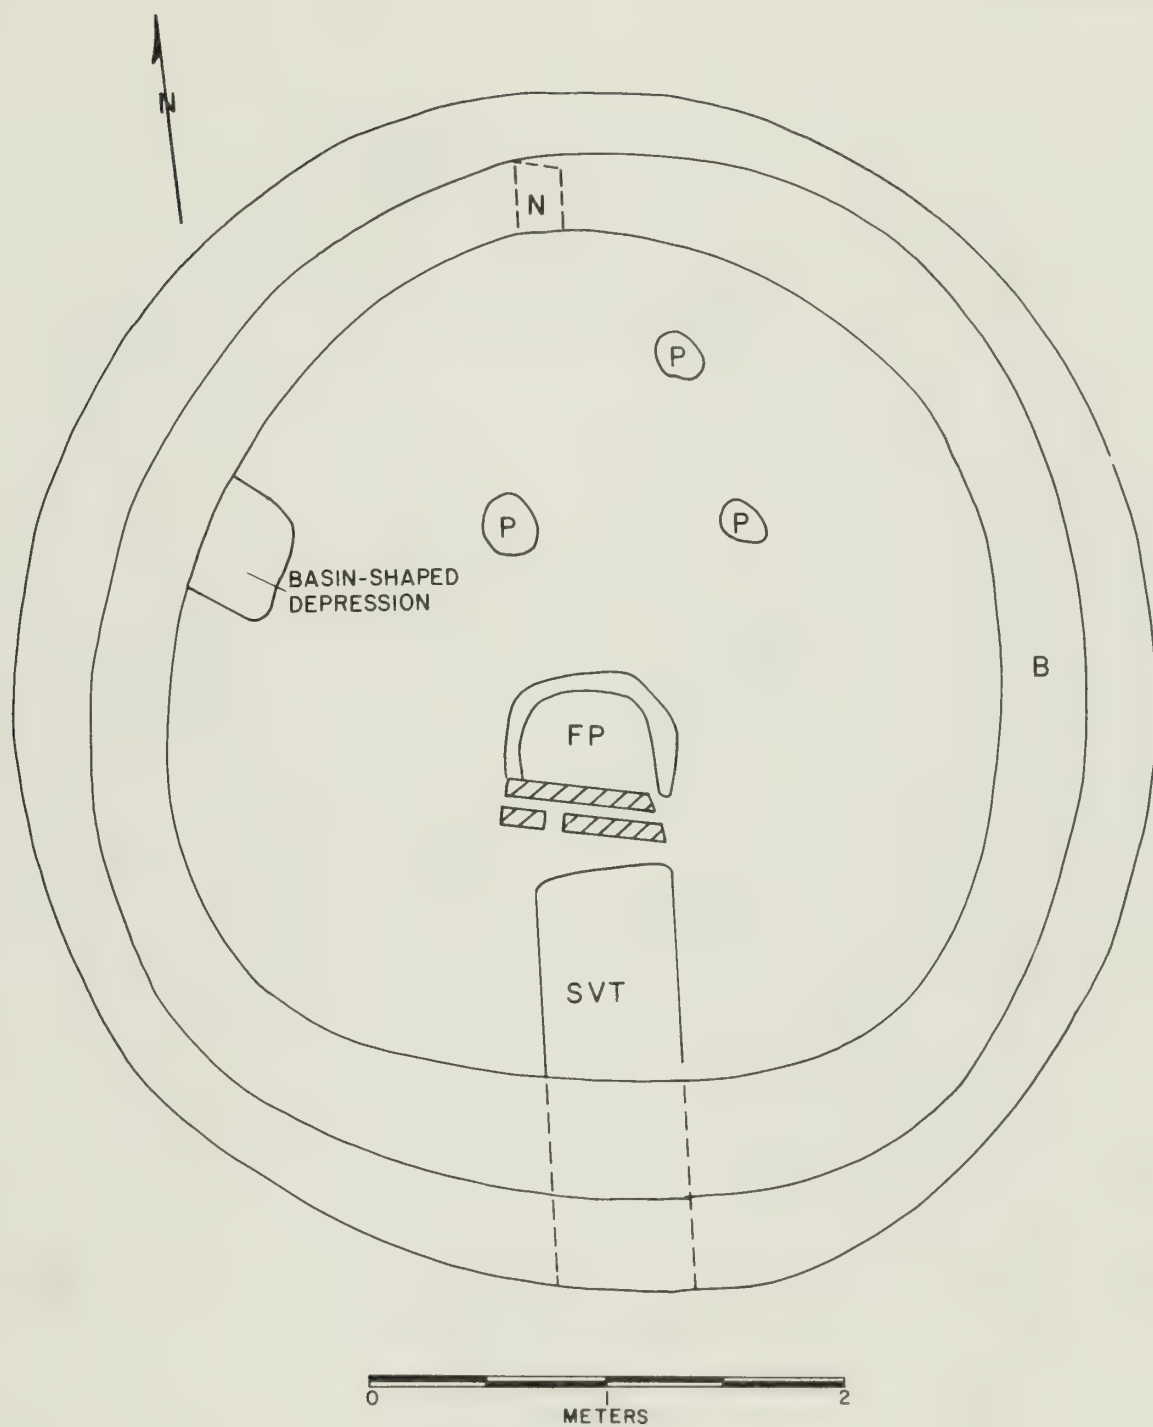
Figure A.51. Three-C site, Kiva 1 (after Vivian 1965).

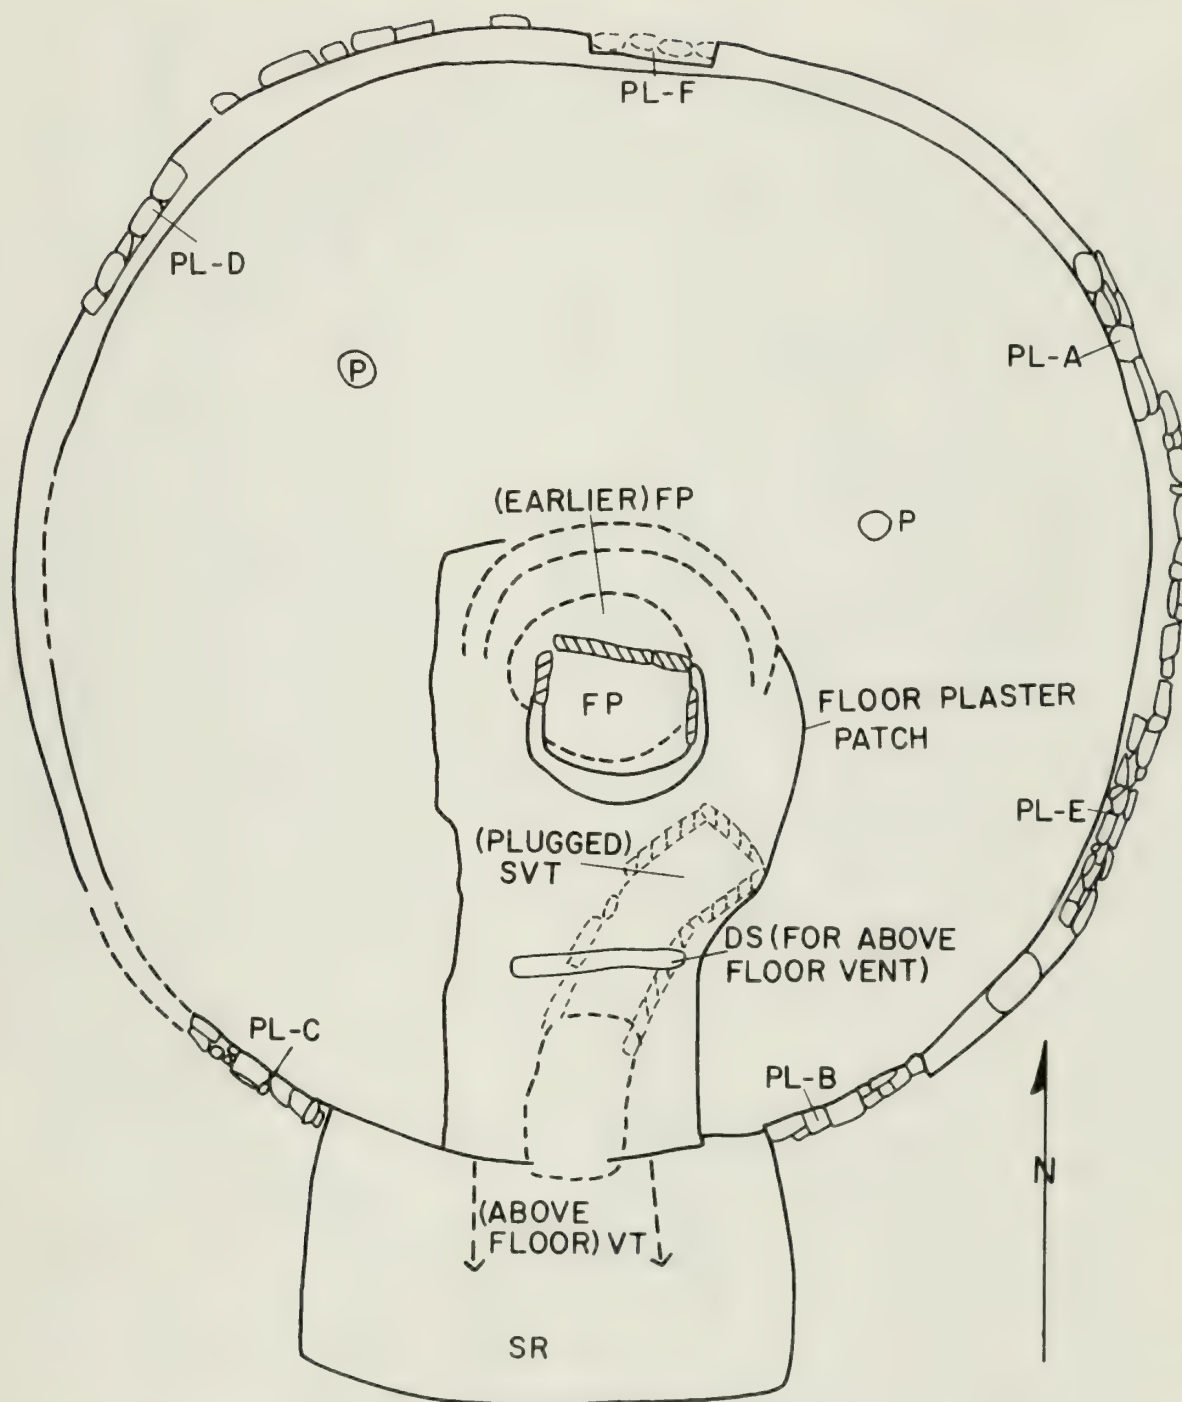
Figure A.55. Site 29SJ 627, Kiva E (after Truell 1981).

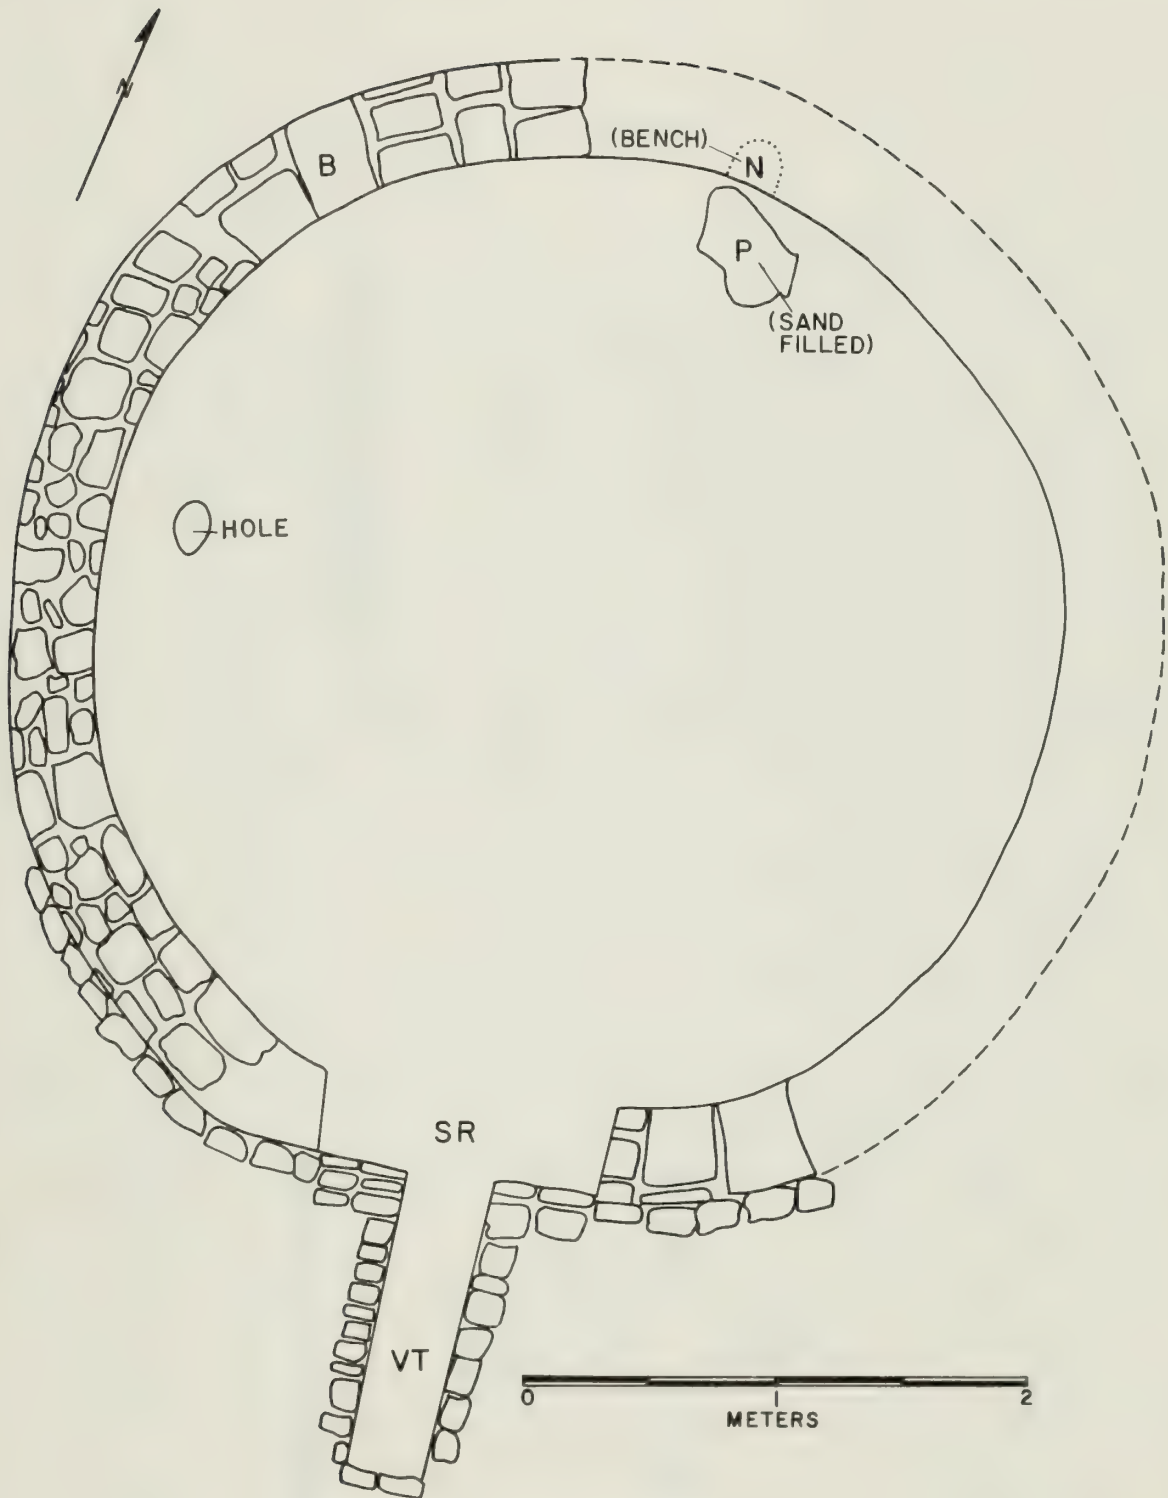
Figure A.57. Site 29SJ 721, Kiva (after Windes 1975b).

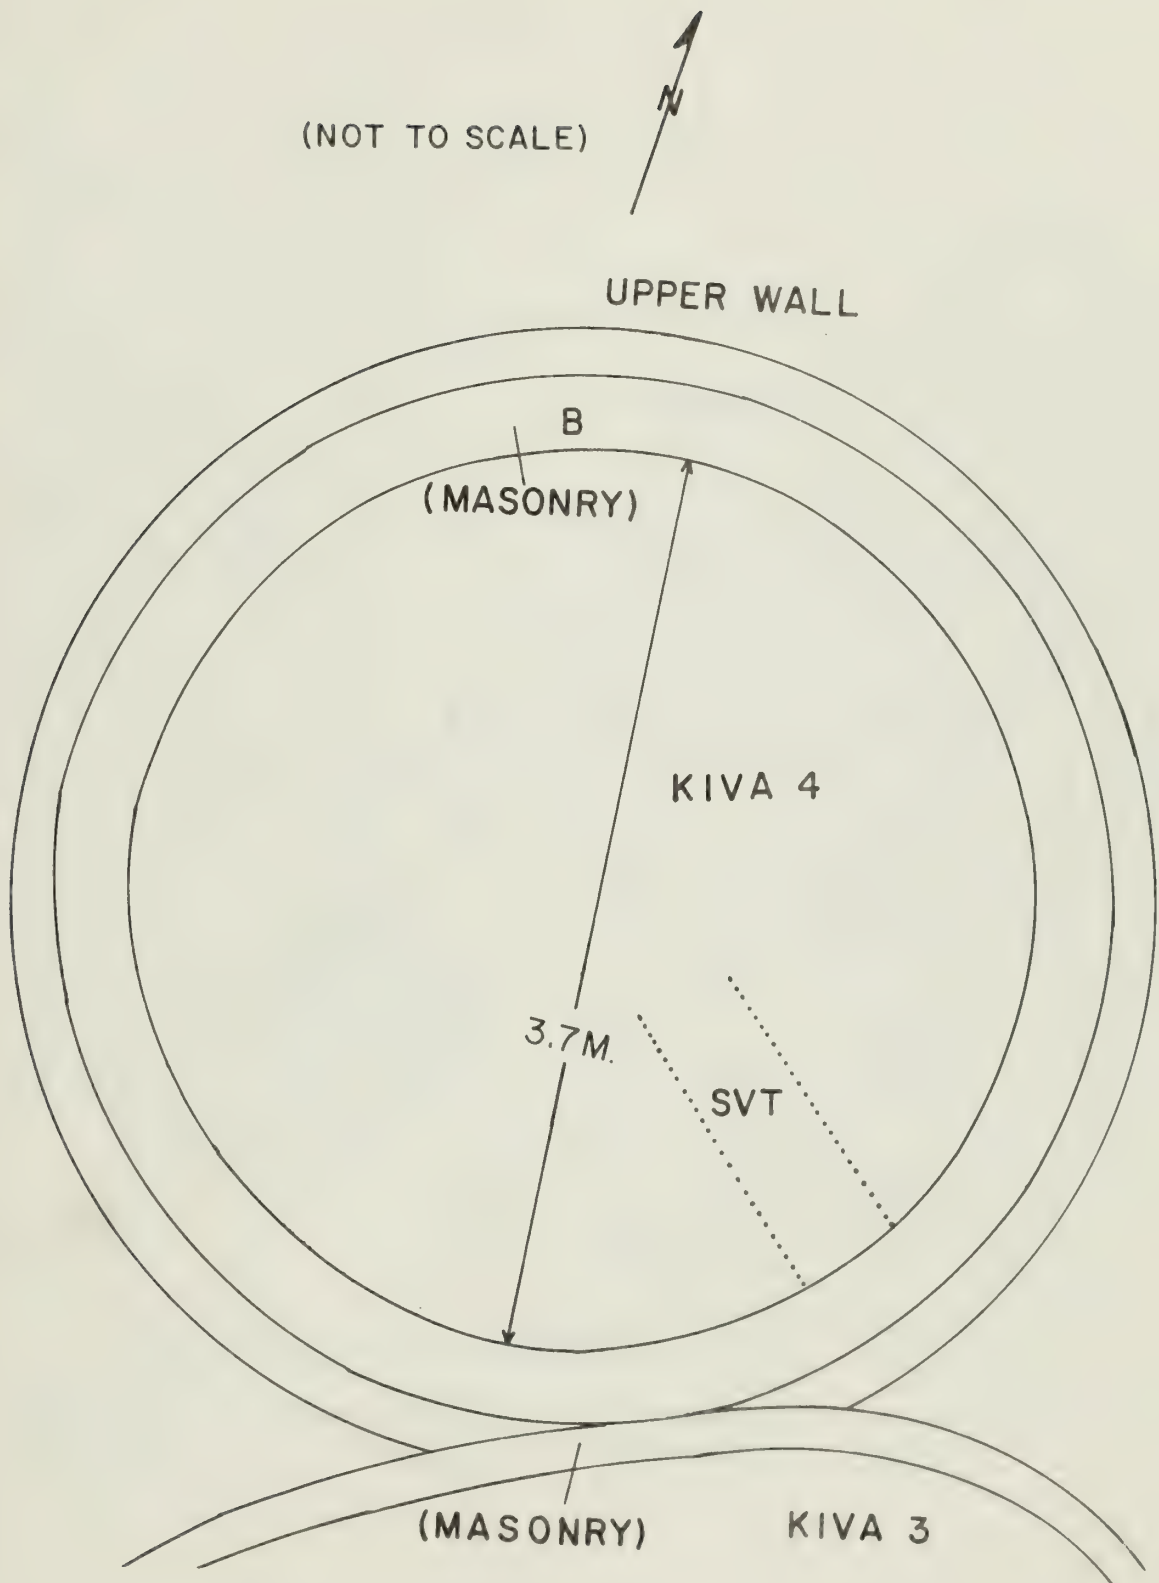
Figure A.63. Bc 51, rough sketch of Kiva 4.

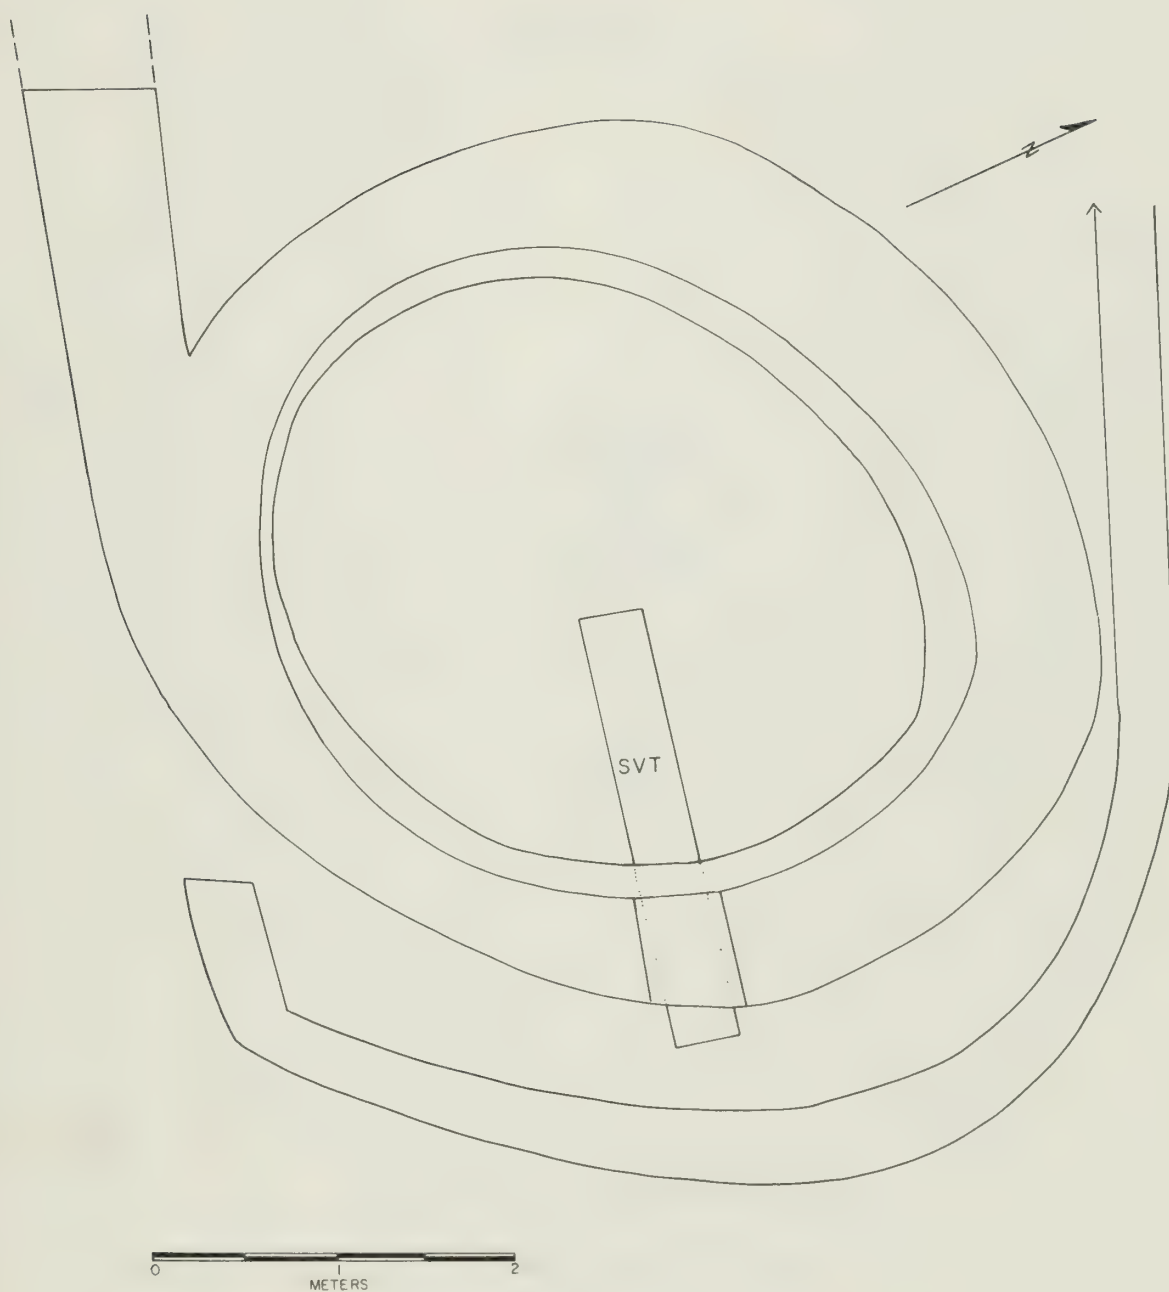
Figure A.65. Bc 52, rough sketch of Kiva 2 (after Vivian).

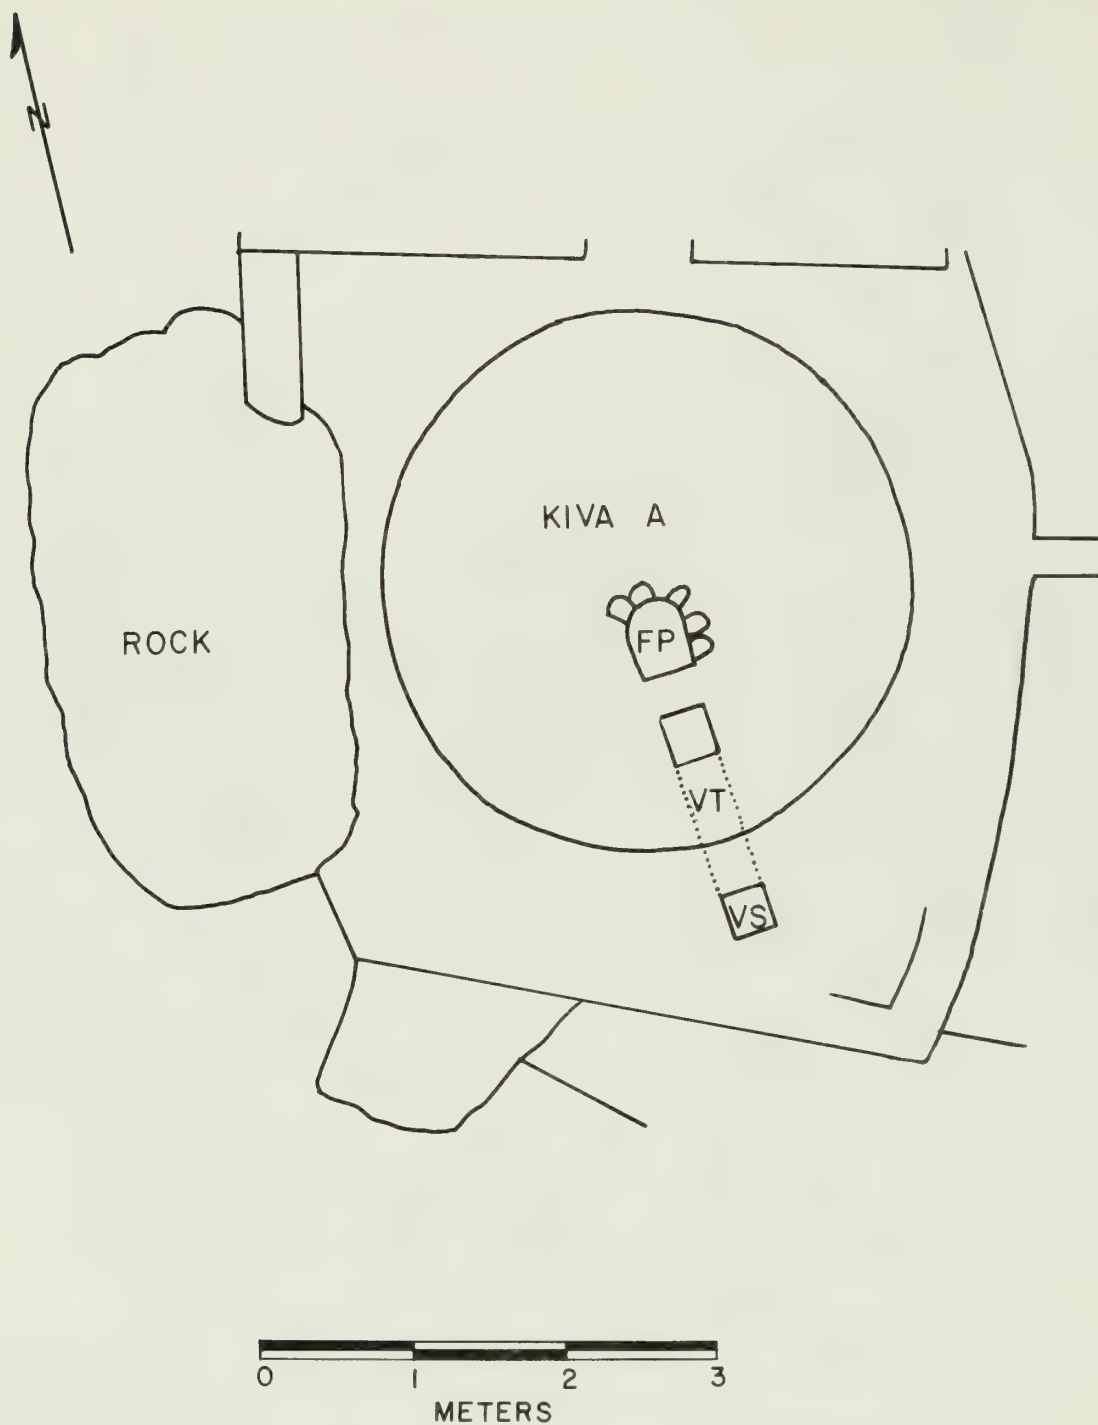
Figure A.70. Bc 54, rough sketch of Kiva A (Chaco Center Archives #2086c).

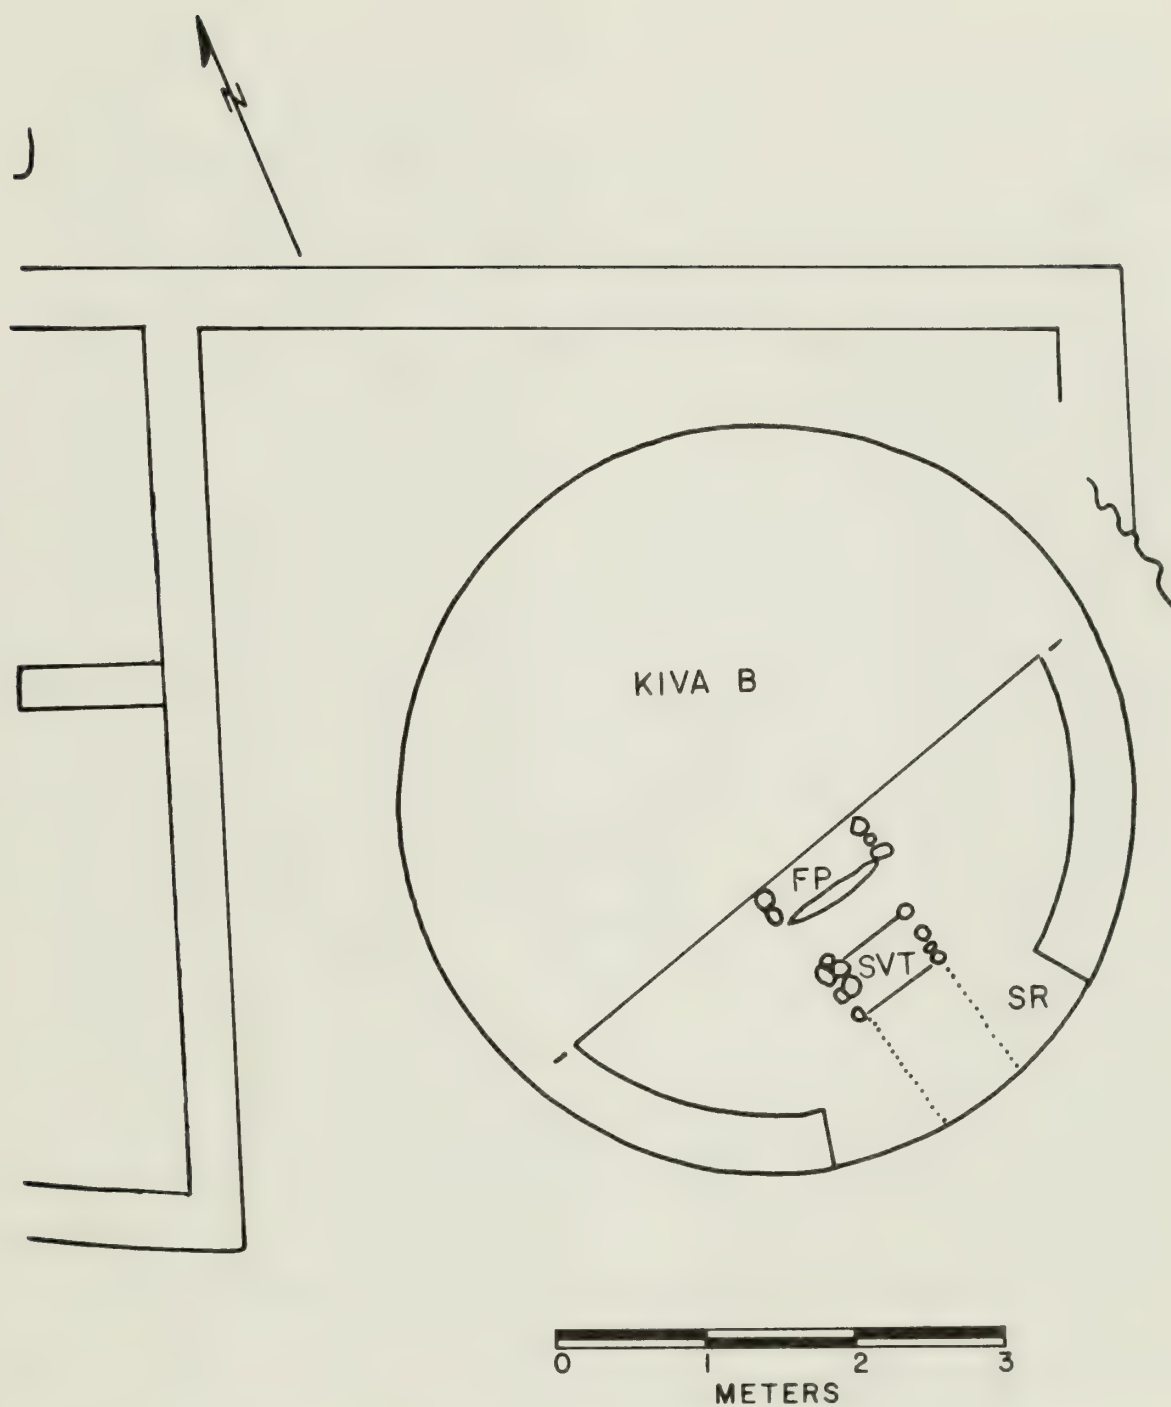
Figure A.71. Bc 54, rough sketch of Kiva B (Chaco Center Archives #2086c).

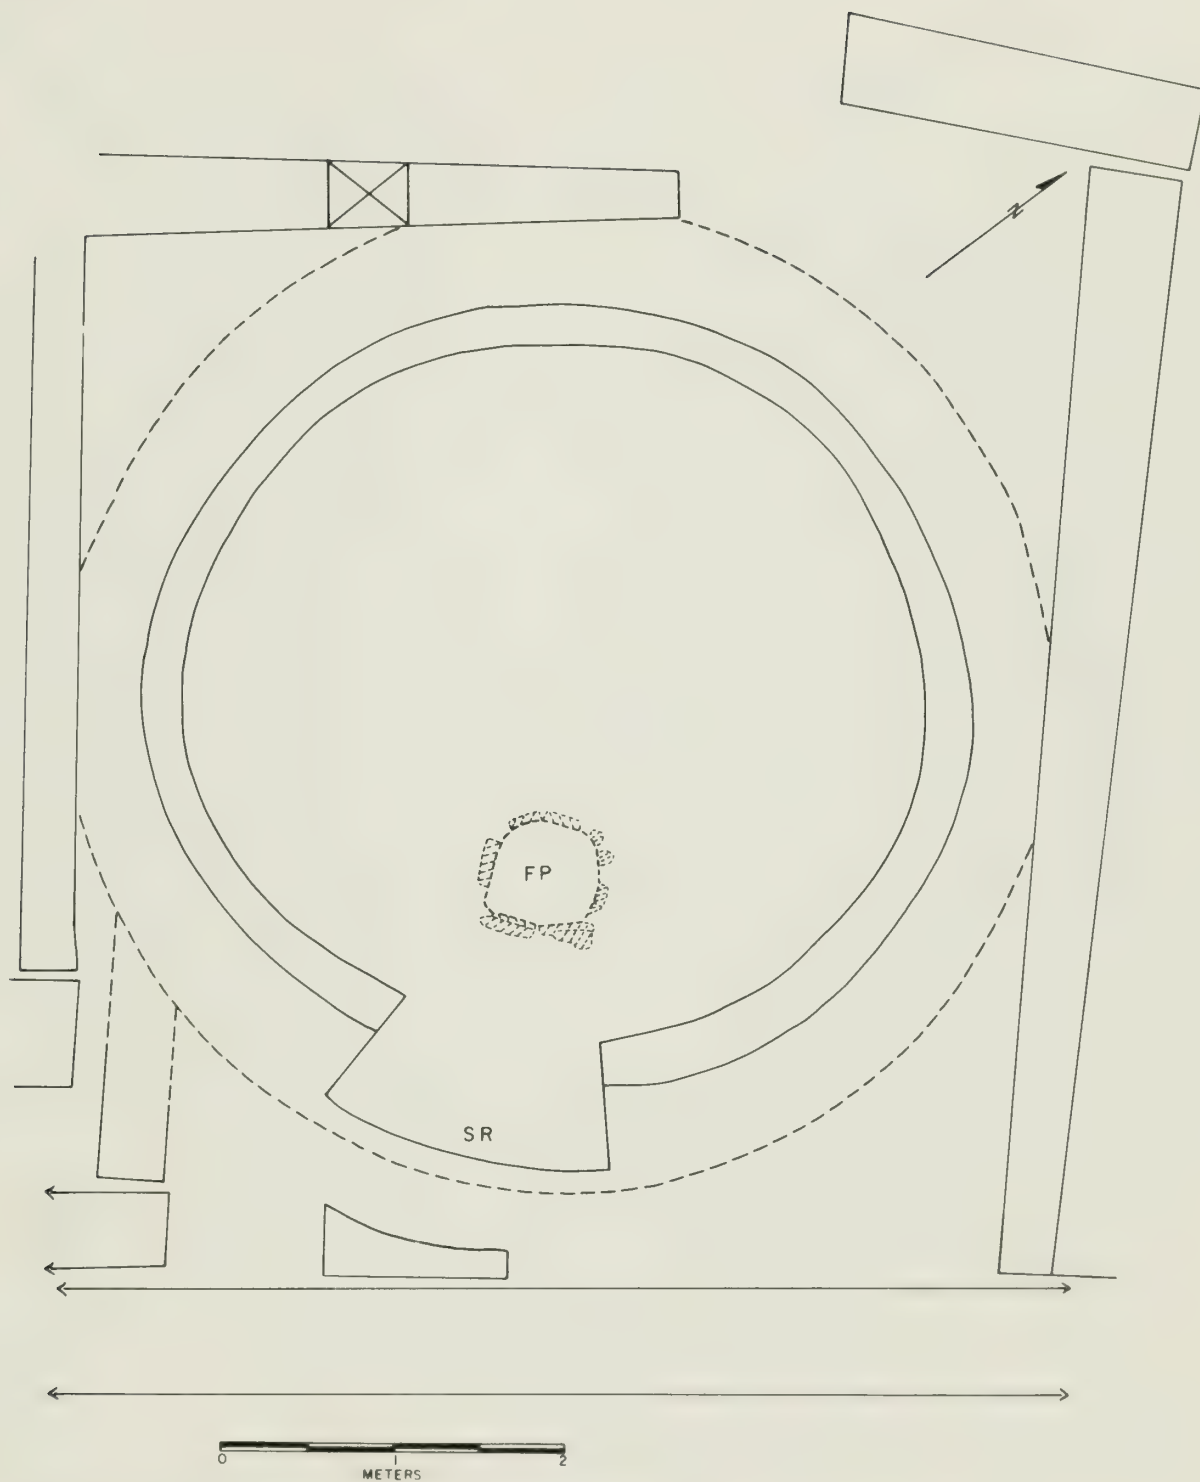
Figure A.73. Bc 57, rough sketch of Kiva C.

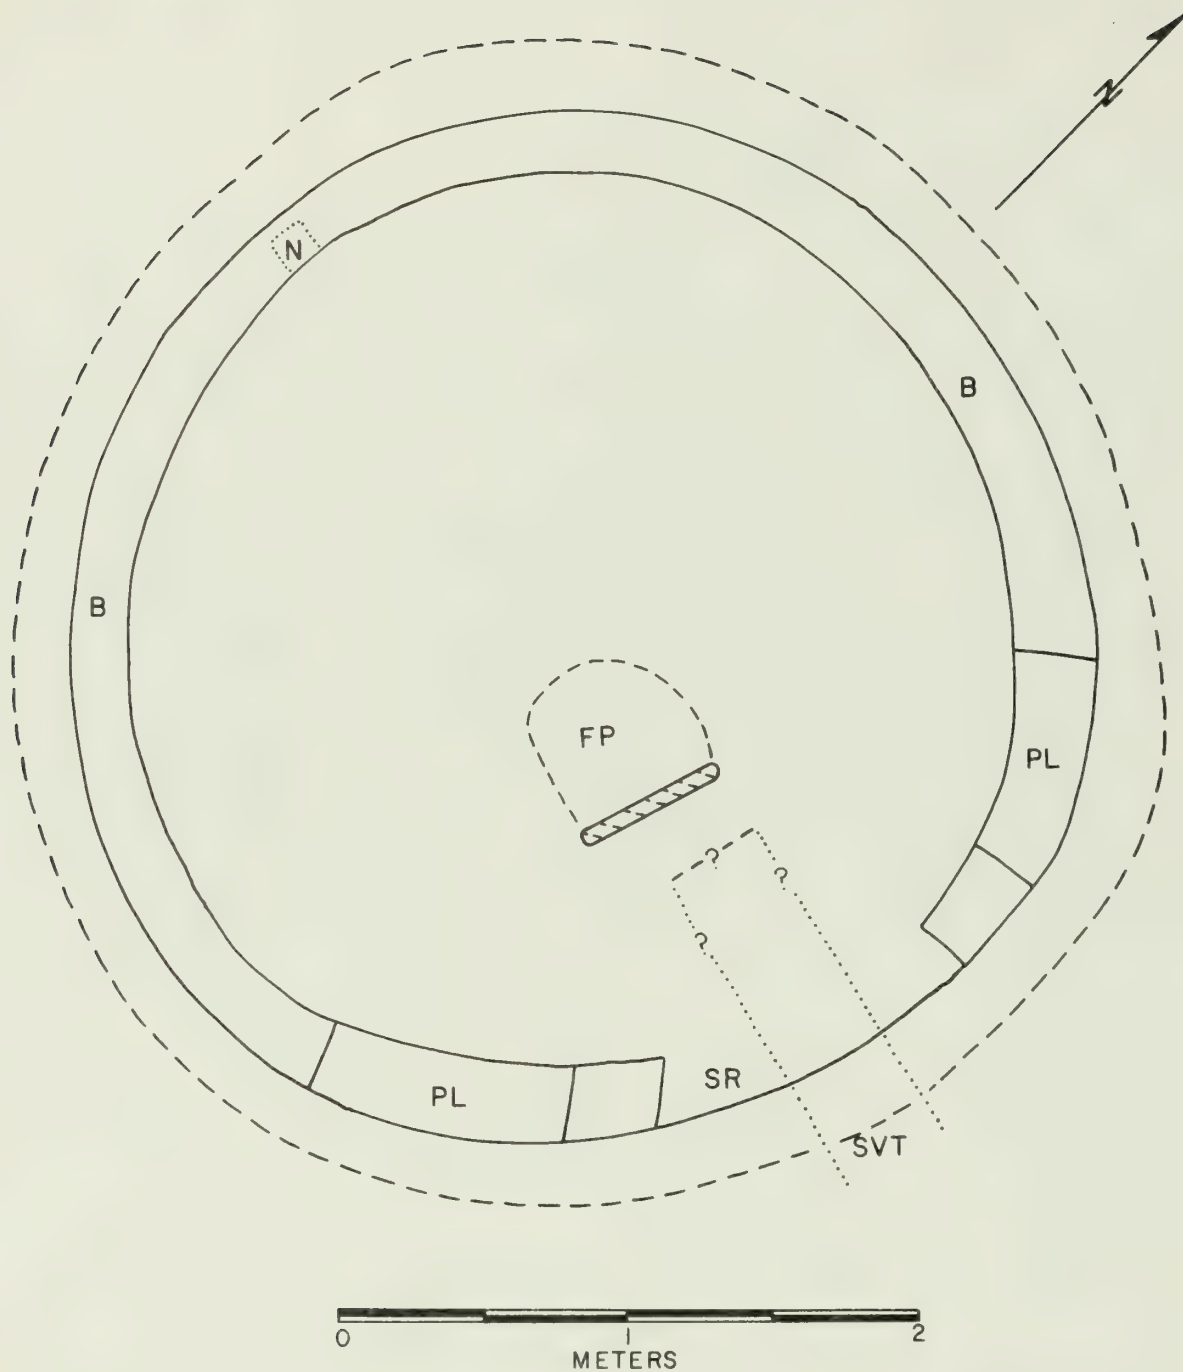
Figure A.74. Bc 58, rough sketch of Kiva A.

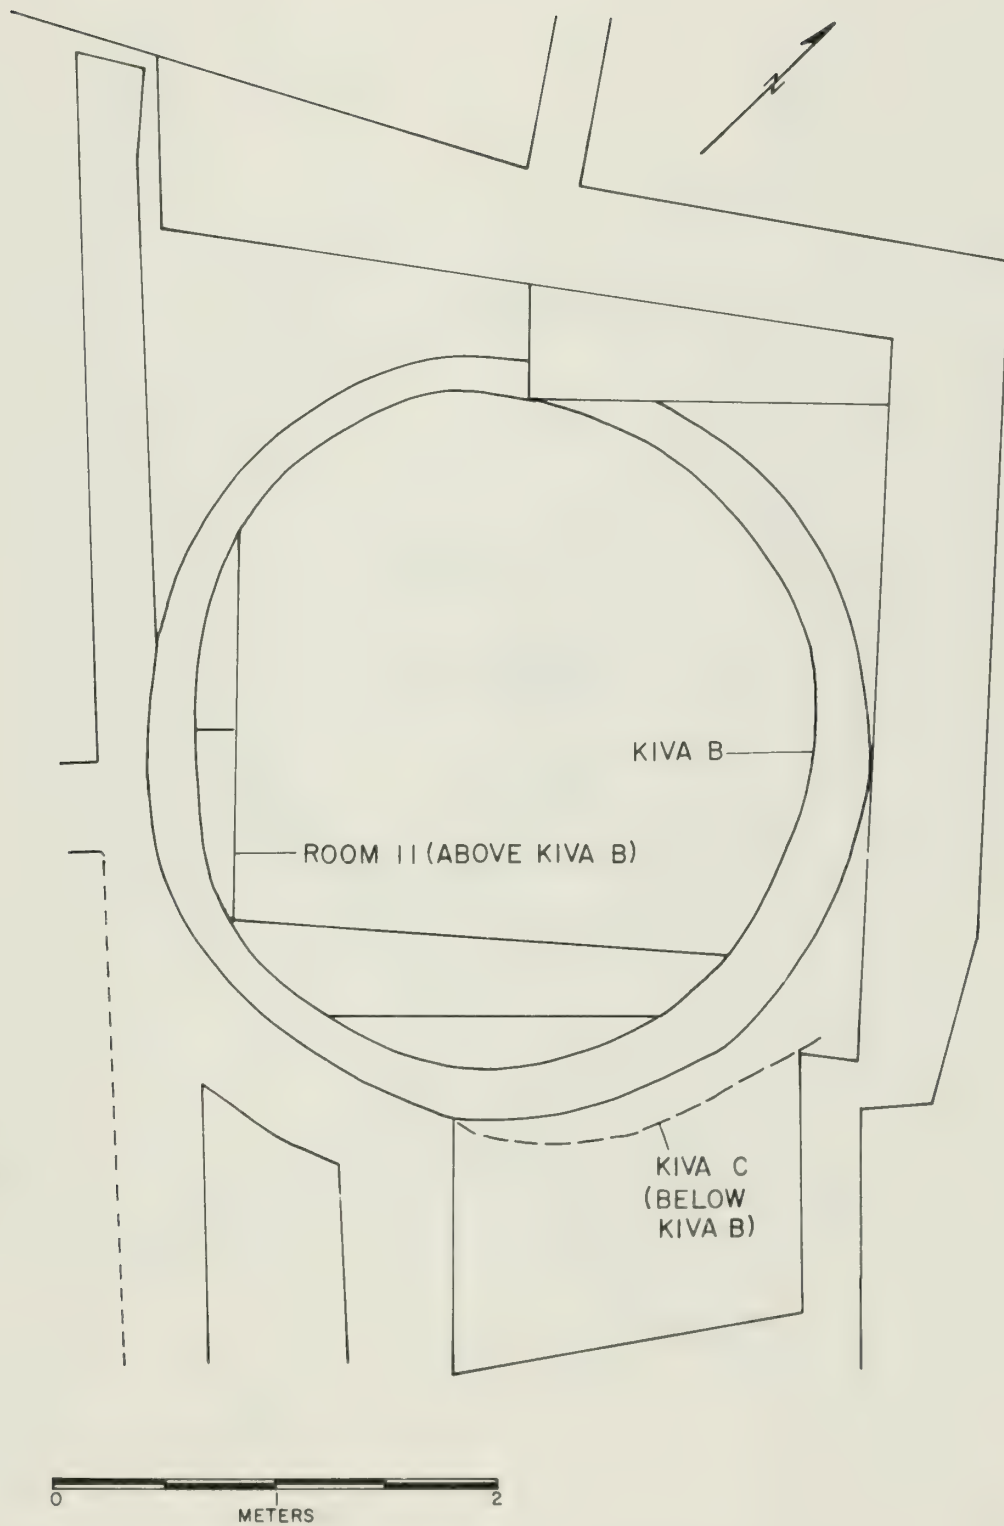
Figure A.75. Bc 58, rough sketch of Kiva B.
